Froedtert Malt

Milwaukee, Wisconsin

PROJECT PROFILE 001

BRINGING NEW LIFE AND STABILITY TO A CRUMBLING SOLID CONCRETE STRUCTURE.
A DEMONSTRATION IN THE VERSATILE USE OF SHOTCRETE REPAIR.

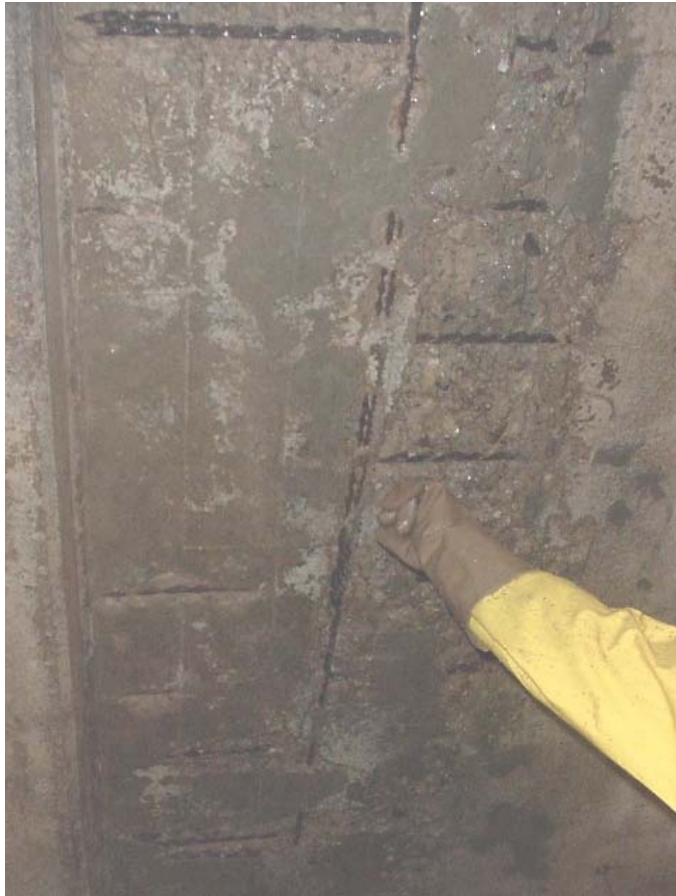
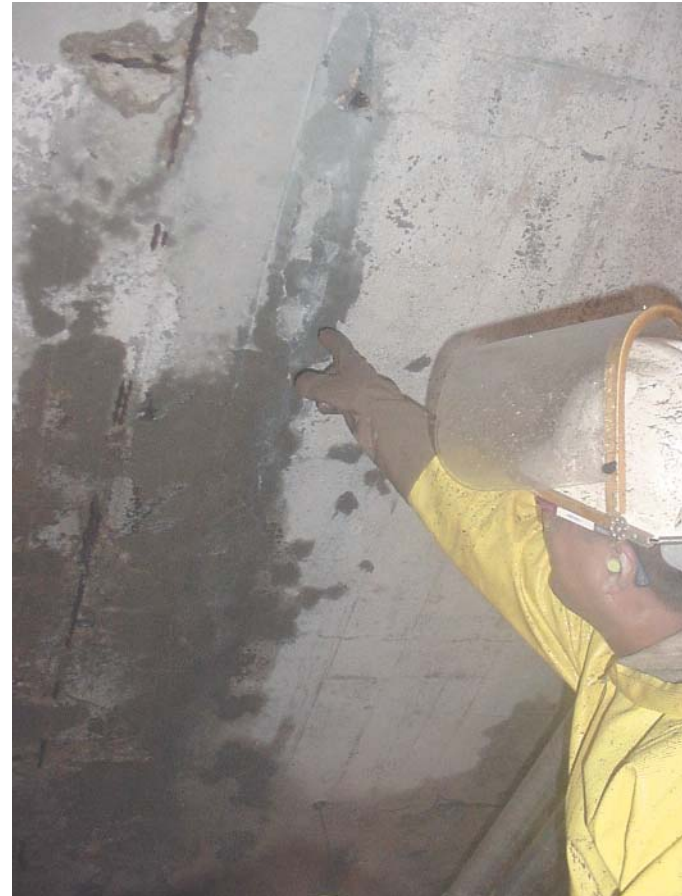
PHOTOS ABOVE: THE STRUCTURE ALSO HAD BEEN EXPOSED TO HIGH TEMPERATURES AND CONSTANT HUMIDITY. THE RESULT WAS THAT THE CONCRETE HAD BEEN ERODED TO THE POINT WHERE THE REINFORCING STEEL WAS EXPOSED AND CORRODING.

David Graham Construction Co. offered a third more viable solution—shotcrete. With the help of the SPEC MIX® Technical Services Department, a project field analysis concluded that NaO^3 was attacking the structure and a micro silica, fiber reinforced shotcrete would perform beyond expectations for the project. David Graham Construction Co. suggested the unobtrusive and highly cost effective hydro-demolition method for both removing deteriorated concrete and cleaning corroded reinforcement.

Once the deteriorated concrete was removed and the existing reinforcement was free of corrosion, SPECSHOT 5000 MSF was introduced to the shotcrete machine outside the structure and conveyed to the work area pneumatically as high as the fifth story. A steel fibered SPECSHOT 5000 MS was used in areas where the existing reinforcement was too deteriorated to be salvaged.

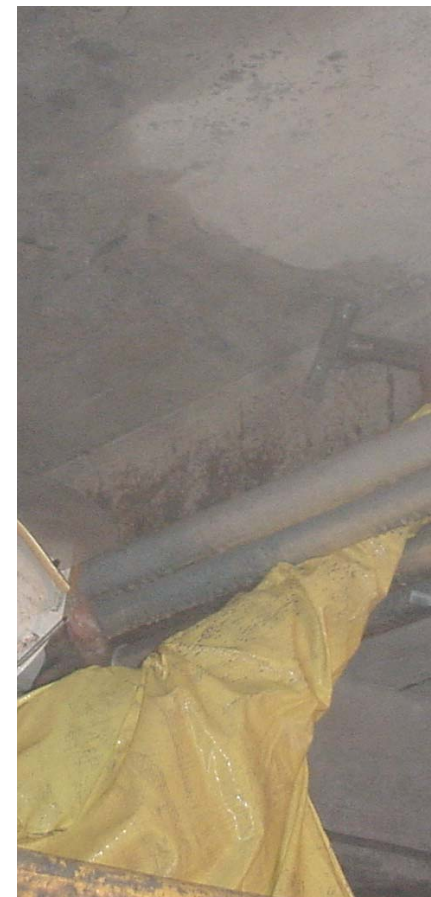
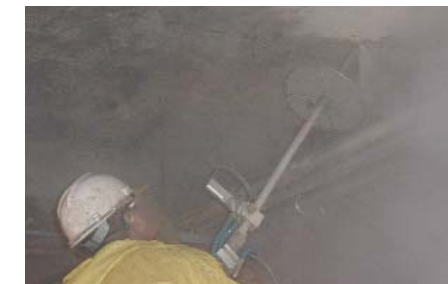
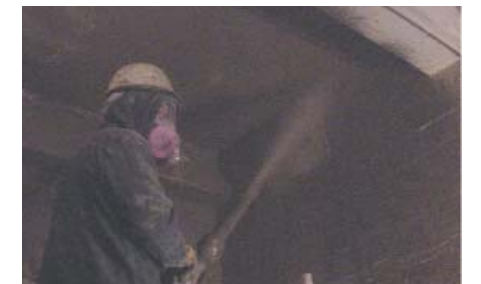
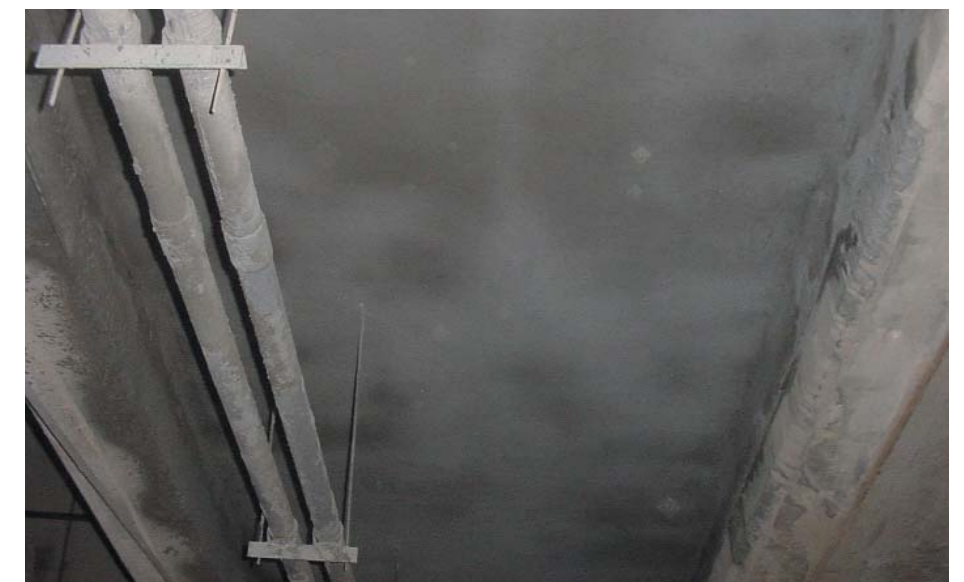
PHOTOS BELOW: ALL OF THE SHOTCRETE WORK WAS TROWEL FINISHED SMOOTH TO MAKE THE PROJECT AS GOOD AS NEW UPON COMPLETION. THE PROCESS ALLOWED THE OTHER TRADES TO CONTINUE WORKING ON THE PLANT REHABILITATION AND FOR FROEDTERT TO MAKE THEIR DEADLINE.

All of the shotcrete work was trowel finished smooth to make the project as good as new upon completion. The process allowed the other trades to continue working on the plant rehabilitation and for Froedtert to meet their deadline.
